December 17, 1998

Site Inspection, San Rafael Energy, Inc., Probe Mine, S/015/011, Emery County, Utah

Purpose of Inspection: To examine the reclaimed mine site and shaft closures in consideration of

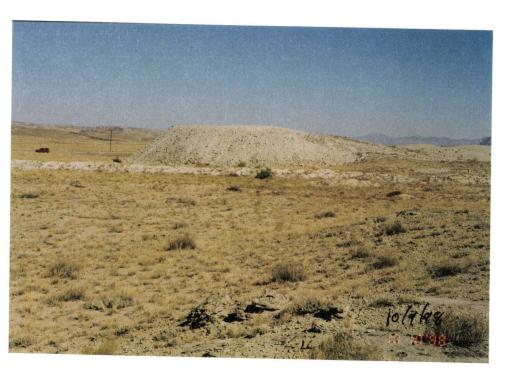
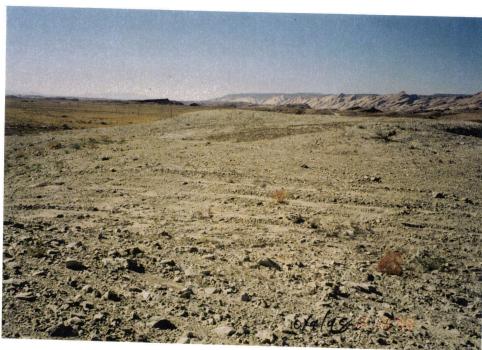
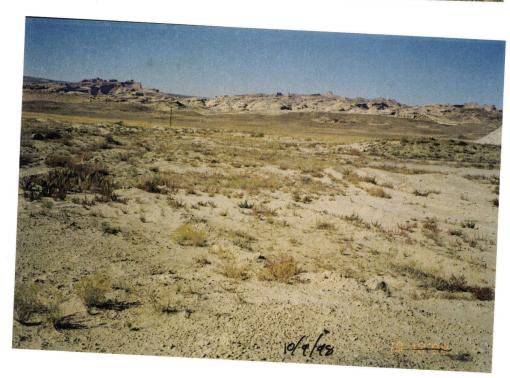
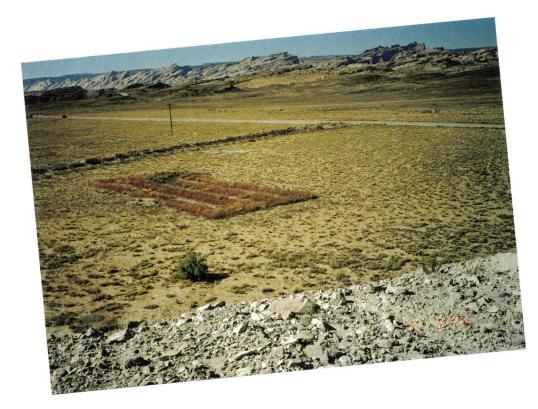
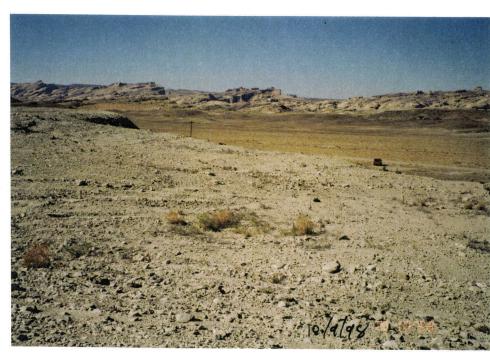
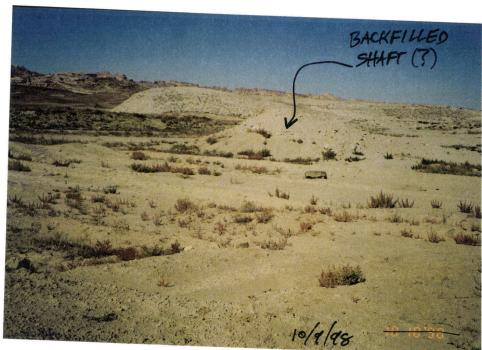
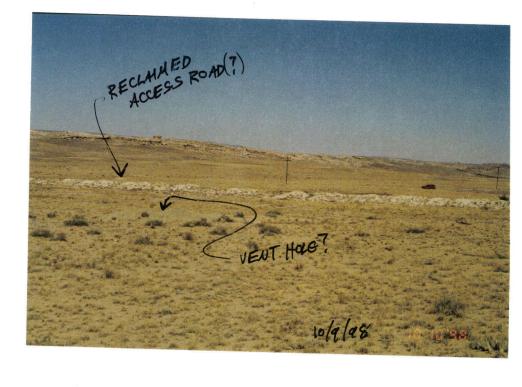
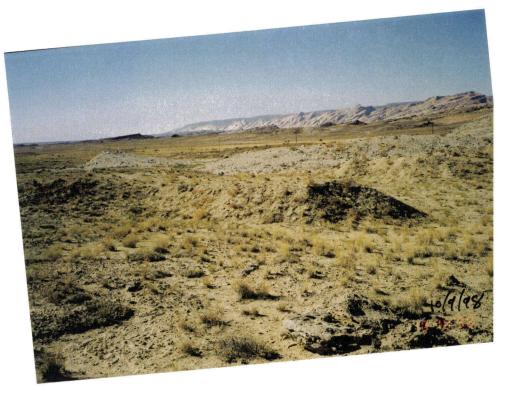
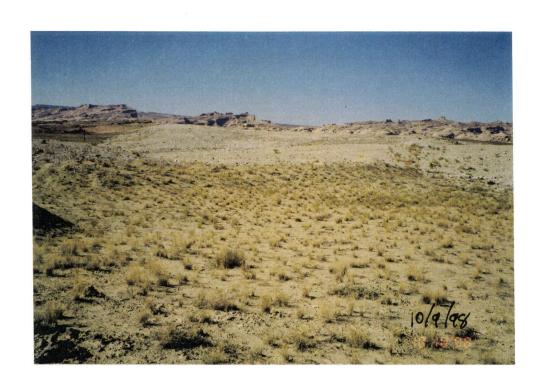
S/015/011 PROBE MINE

The inspection began at the southern edge of the angle of repose mine dumps. Photos were taken of the dumps looking north at the mine area. Visible in these photos is a line of mounded waste material over the access road. From the southern edge I walked around to the east end of the mine site. All structures have been removed from the site. There were some desirable plant species on portions of the pad area, mainly indian ricegrass. Plants are generally located in areas which have topsoil mixed in or with topsoil covering the waste material. Most of the plants on the pad area are russian thistle and halogeton. Additional photos looking toward the west show the reclaimed access road and waste dump.

There is very little vegetation on the waste rock dump. Photos were taken looking toward the south -southeast showing the top of the waste rock dump. The dump top was graded toward the east with the west facing dump slopes left at the angle of repose. One unusual feature at the site was a rectangular area of vegetation. Photographs were taken of this vegetation located on the south side of the waste dump between the dump and the reclaimed road. This area may have been a drainage field or leach field associated with the mine operation.

The shaft site is believed to be visible as a large mound of waste material. This mound shows no signs of settling or instability at this time. A GPS unit was used to obtain a location point at the shaft site. The point was named "probe" in rover file R100917A. The uncorrected position in latitude and longitude given by the GPS unit was north 38° 59' 20.34", west 110° 21' 06.15". The corrected location for the point in UTM coordinates was East 556,194.86702 North 4,315,537.98506.

According to Division files there was an additional ventilation hole at this site located to the south of the main dump. During this inspection, the location of a vent hole was not evident; however, there was a small mound of soils located south of the reclaimed access road. Unless the ventilation hole is in some entirely different location this would imply that the backfill of the vent hole was stable and there was no settling. The maps in the Division files will need to be checked to verify the location.

In conclusion, this site appears to be stable from an erosional standpoint. With respect to safety issues, the shaft closure is intact and the vent hole or escapeway closure is also stable. Vegetation success on the waste rock dump, low grade ore stockpile and ore stockpile areas is poor in general with the best results on the flat areas which have some soils mixed in. The waste rock slopes which were left at angle of repose have very little vegetation. A letter addressing reclamation release will need to be sent to the operator after consulting the BLM and reviewing Division files.
